## Evaluation of Restoration Alternatives for the Northwest Fork of the Loxahatchee River

**South Florida Water Management District  
Watershed Management Department  
Coastal Ecosystems Division  
March 21, 2005**

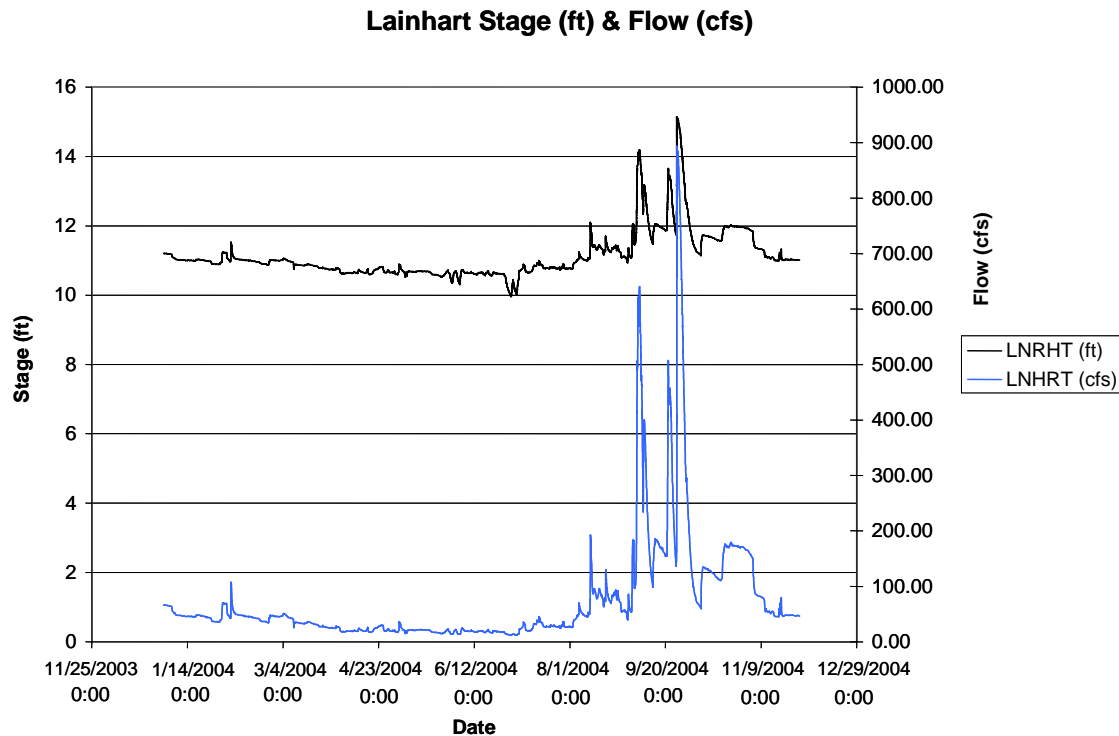
**Figure 5-3.** Northwest Fork River Stages and Flows at Lainhart Dam for the Period November 2003 through December 2004.

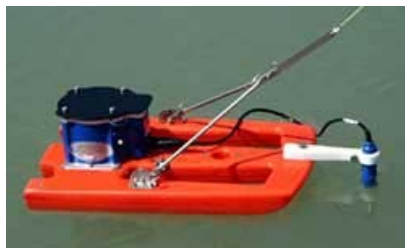
**Figure 5-4.** StreamPro 2400-KHz Acoustic Doppler Current Profiler (ADCP).

The flows in the Northwest Fork of the Loxahatchee River measured by the Operations and Hydro Data Management staff on August 17, 2004, in support of the Loxahatchee River stage discharge development effort, were collected with a StreamPro acoustic profiler manufactured by RD Instruments (RDI), see **Figure 5-4**. StreamPro is a small monostatic, four-transducer, 2400-KHz Acoustic Doppler Current Profiler (ADCP) mounted on a tethered platform.

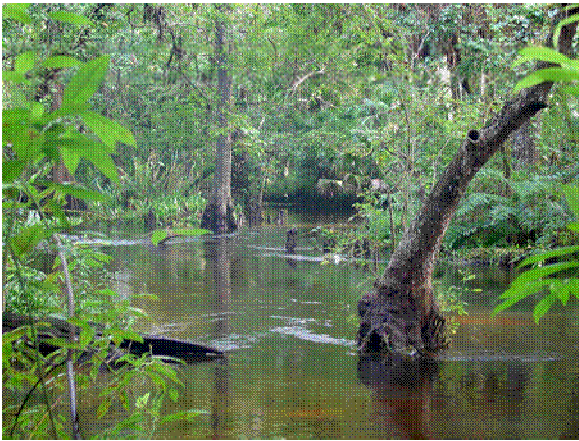
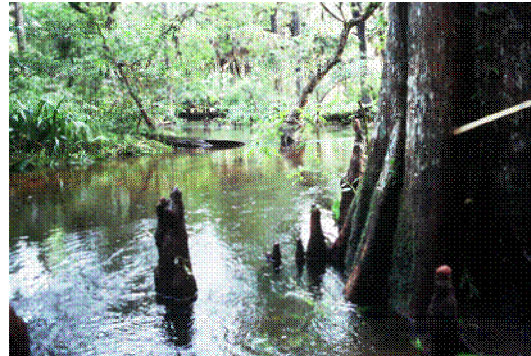
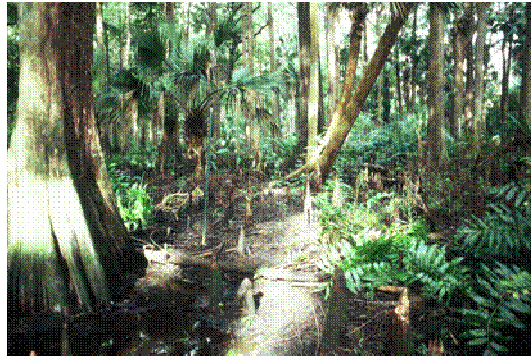
**88 cfs 8/13/04 9:30**

- No Flow Outside of Channel
- Standing Water In Floodplain
- Remnants of Release From G-92 Max.  
Flow = 192 cfs

**Downstream of Stage Measurement site 9:05**

**Tag #601 and #602 9:15**

**Standing Water at 75m West 9:30**

**Figure 5-6.** River Stage Conditions at Transect 1 on 8/13/04 With 88 cfs Discharge at Lainhart Dam.

**Figures 5-6 through 5-10** are photographs of the river and floodplain at Transect 1 taken over a range of flows ranging from 88 to 476 cfs during the observation period. **Figure 5-11** is a cross-sectional profile of Transect 1 based on survey data on June 2003. Water stage elevations as measured on the dates indicated are depicted. The depth and lateral extent of floodplain inundation is readily evident at each level of inundation. Flows are contained in the main river channel up to and through 88 cfs. That discharge creates an associated river stage of approximately 9.4 feet NGVD. Water levels at that stage remain slightly to well below the lateral ground surface elevations in the floodplain.

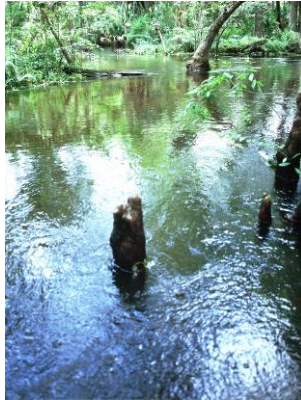
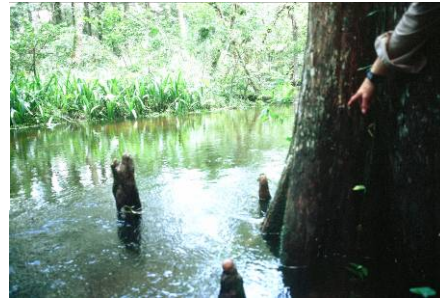
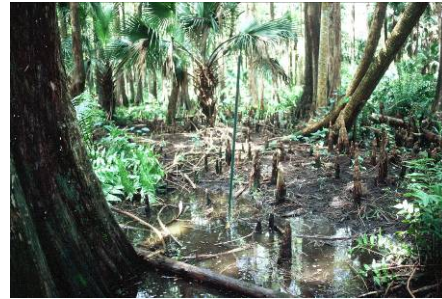
114 cfs 8/12/04 12:50

- Water Level At Top of Bank
- Standing Water in Floodplain
- Debris Piled On Banks
- Ebbing Side of Controlled Release From G-92

Downstream of Stage Measurement Site and Tag #602 12:00

Tag #601 and #602 12:00

Standing Water at 75m West 12:15

**Figure 5-7.** River Stage Conditions at Transect 1 on 8/12/04 With 114 cfs Discharge at Lainhart Dam.

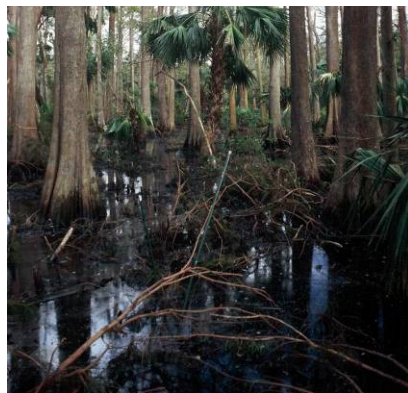
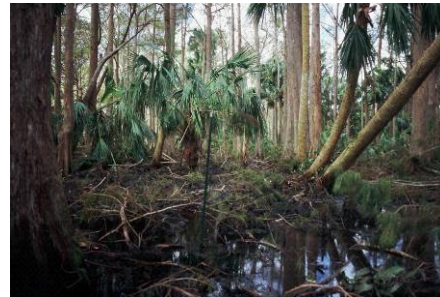
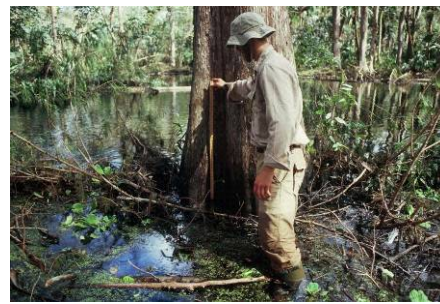
241 cfs 9/10/04 10:40

- Water Over Top of Bank
- No Visible Flow in Floodplain
- A Lot of Debris
- Floodplain Inundated Knee Deep

Edge of Floodplain 10:30

Floodplain Inundated at 75m West 10:50

Measuring Tag #601 10:45

**Figure 5-8.** River Stage Conditions at Transect 1 on 9/10/04 With 241 cfs Discharge at Lainhart Dam.

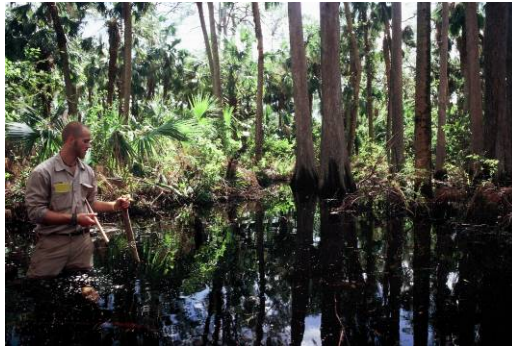
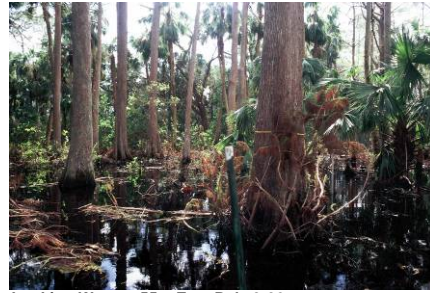
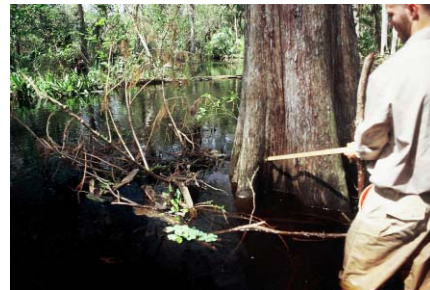
288 cfs 9/23/04 2:52

- Water Over Top of Bank
- Visual Flow in Floodplain
- Thigh Deep in Floodplain

Edge of Floodplain at 45m West 2:45

Looking West at 55m East Pole 3:06

Looking Downstream at Tag #601 2:52

**Figure 5-9.** River Stage Conditions at Transect 1 on 9/23/04 With 288 cfs Discharge at Lainhart Dam.

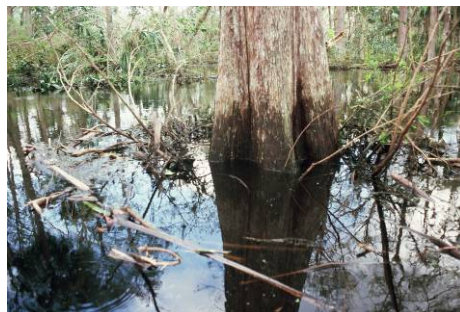
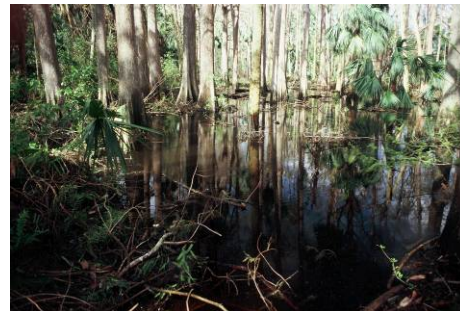
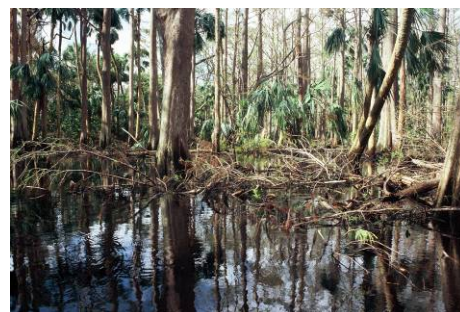
476 cfs 9/29/04 10:18

- Water Level at Top of Floodplain
- Waist Deep In Floodplain
- Few Cypress Knees Above Water Surface
- Flow Visually Observed in Floodplain

Looking Downstream at Tag #601 10:18

Edge of Floodplain Looking East 10:13

At 75m looking West 10:52 10:32

**Figure 5-10.** River Stage Conditions at Transect 1 on 9/29/04 With 476 cfs Discharge at Lainhart Dam.

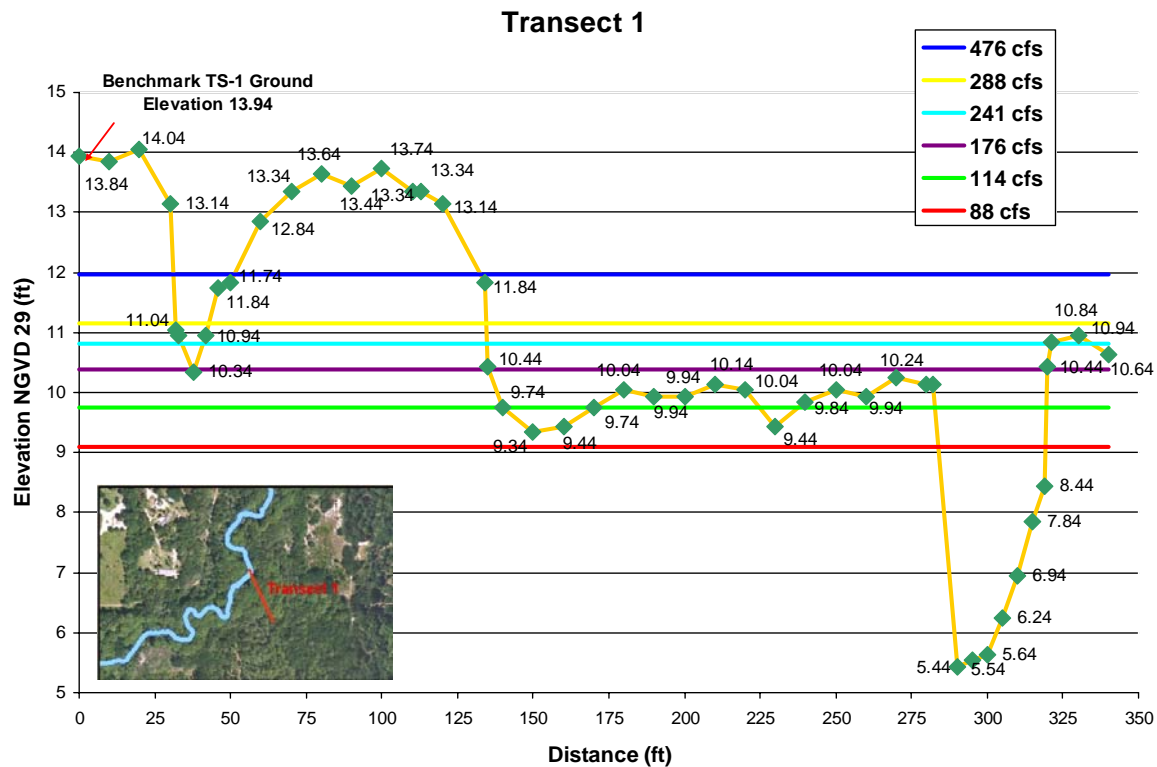
**Figure 5-11.** Transect 1 Cross Section and Observed Inundation Depth and Extent.

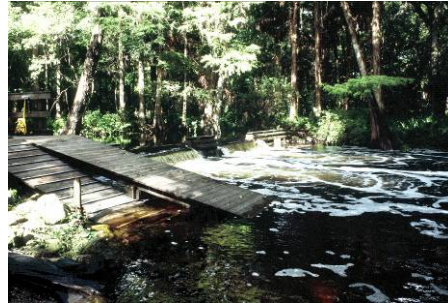
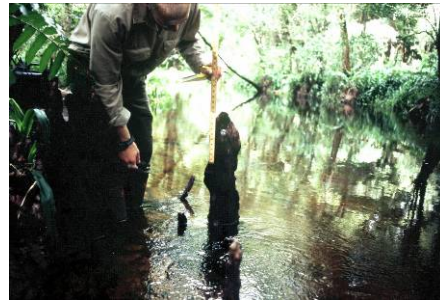
MastenDam 10:00

Below Masten Dam measuring Tag #603 10:15

**Figure 5-12.** River Stage Conditions at Transect 2 on 8/13/04 With 89 cfs Discharge at Lainhart Dam.

**Figures 5-12 through 5-16** are photographs of the river and floodplain at Transect 2 taken over the same range of flows. Transect 2 had two segments. One segment was upstream of Masten Dam and the other was downstream of the dam. **Figures 5-17 and 5-18** are cross-sectional profiles of the upstream and downstream segments of the transect. The profiles depict the depth and lateral extent of floodplain inundation over the range of flows on those dates that water surface elevations were observed and measured.

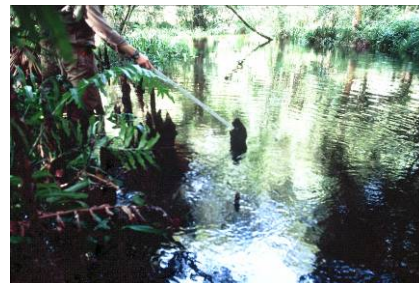
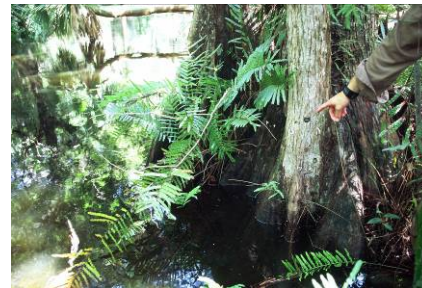
Below Masten Dam Tag #603 10:30

Above Masten Dam Tag #606 10:40

**Figure 5-13.** River Stage Conditions at Transect 2 on 8/12/04 With 121 cfs Discharge at Lainhart Dam.

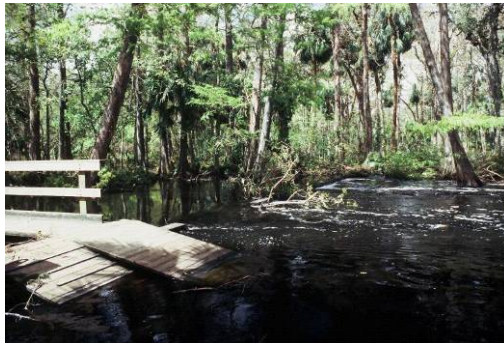
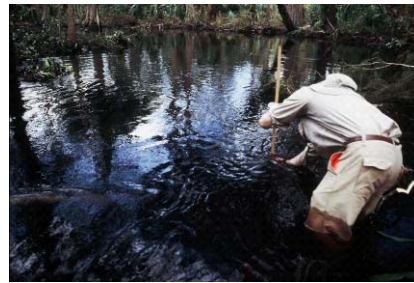
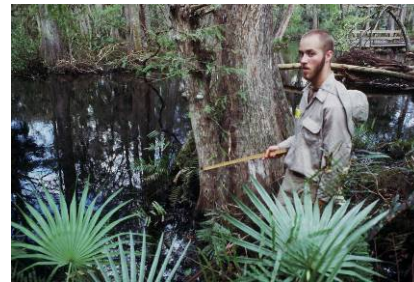
235 cfs 9/10/04 12:23

Masten Dam 11:56

Below Masten Dam Tag #603 12:23

Above Masten Dam Tag #606 12:00

**Figure 5-14.** River Stage Conditions at Transect 2 on 9/10/04 With 235 cfs Discharge at Lainhart Dam.

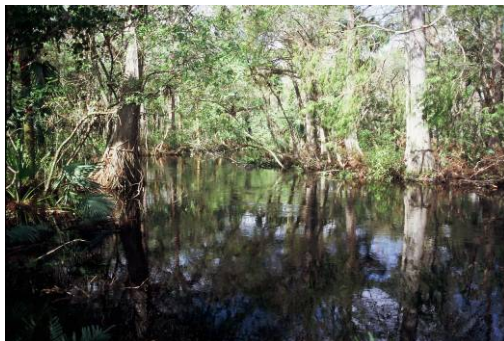
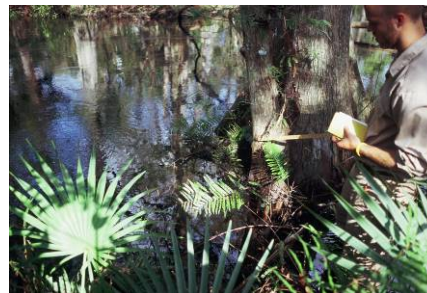
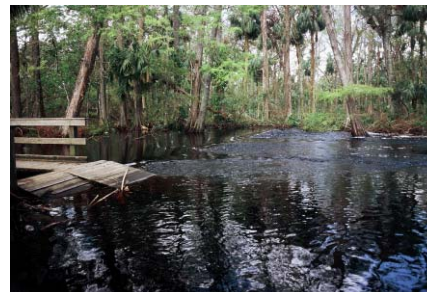
325 cfs 9/23/04 10:02

Above Masten Dam Upstream of Tag #606 10:04

Above Masten Dam Tag #606 10:03

Masten Dam 10:07

**Figure 5-15.** River Stage Conditions at Transect 2 on 9/23/04 With 325 cfs Discharge at Lainhart Dam.

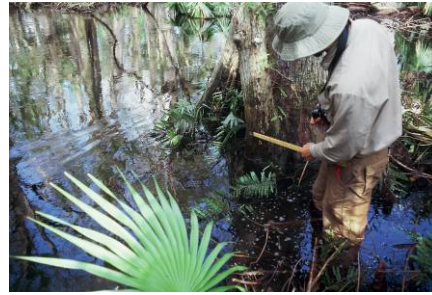
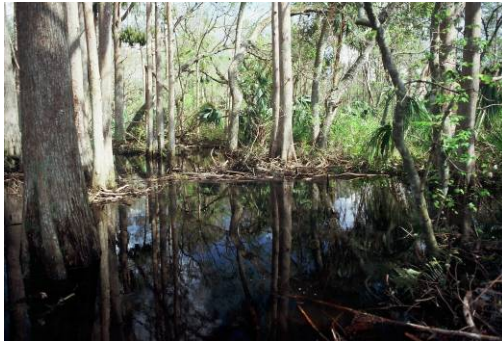
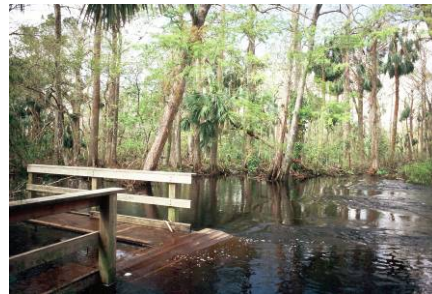
470 cfs 9/29/04 11:05

Above Masten Dam Tag #606 11:15

Floodplain Downstream of Masten Dam 11:20

Masten Dam 11:08

**Figure 5-16.** River Stage Conditions at Transect 2 on 9/29/04 With 470 cfs Discharge at Lainhart Dam.

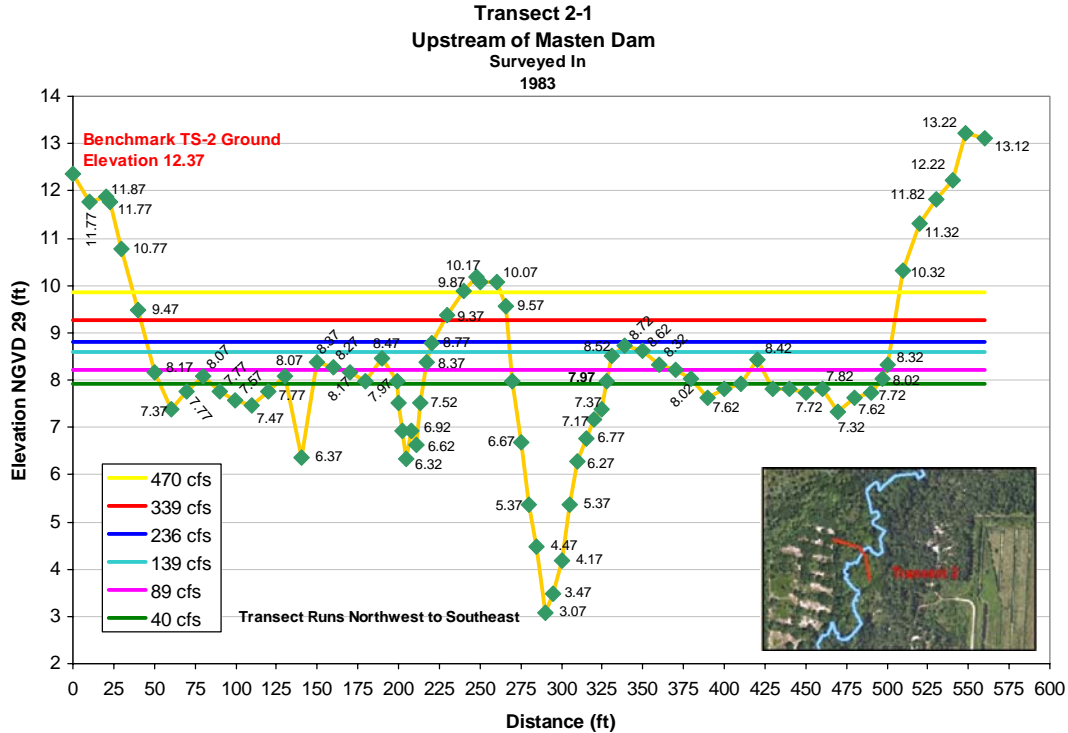
**Figure 5-17.** Transect 2-1 Cross Section and Observed Inundation Depth and Extent.

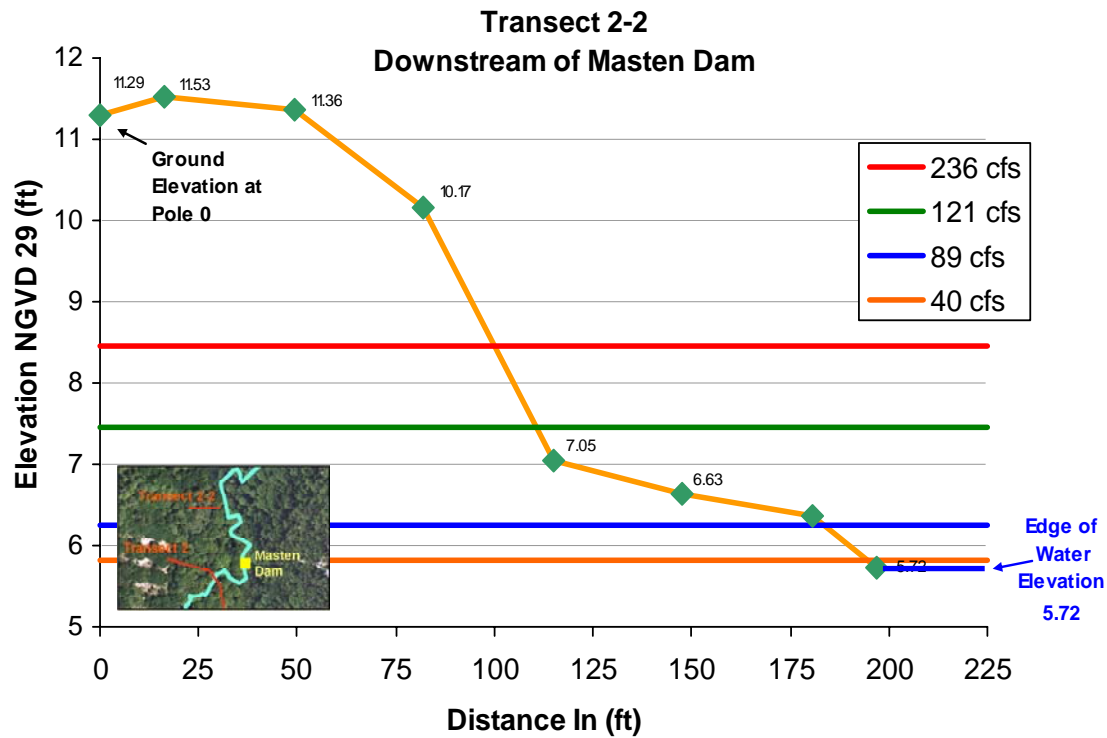
**Figure 5-18.** Transect 2-2 Cross Section and Observed Inundation Depth and Extent.

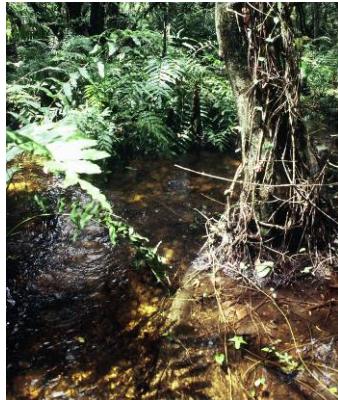
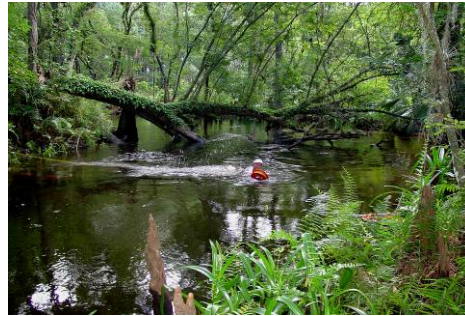
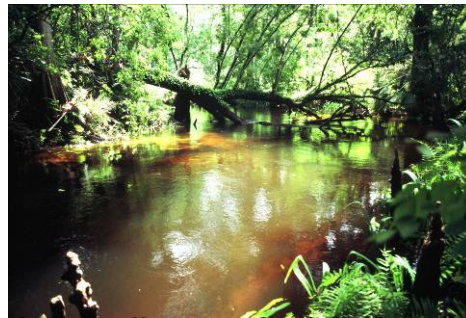
- 83 cfs 8/17/04 9:20
- 91 cfs 8/13/04 11:20
  - Channel Flowing Within Banks
  - Little to No Flow in Braided Streams

Braided Channel at 35m North  
8/13/04 11:54

Flow within the channel: 8/17/04 9:33

Stream Flow Measurement Site 8/13/04 11:33

**Figure 5-19.** River Stage Conditions of Transect 3 on 8/13/04 and 8/17/04 With 83 and 91 cfs Discharge at Lainhart Dam.

**Figures 5-19 and 5-20** contain photographs of the river and floodplain at Transect 3 taken over a range of flows from 81 to 258 cfs. **Figure 5-21** is a cross-sectional profile of Transect 3.

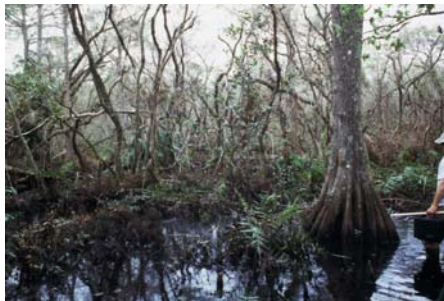
On Transect at 15m Looking West Towards River 9/14/04  
11:45

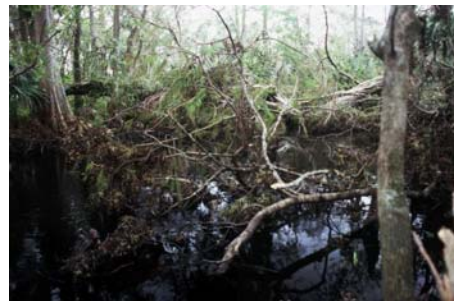
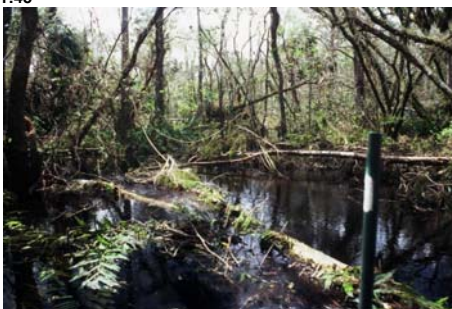
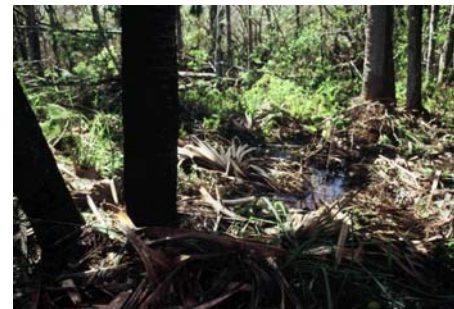
**Figure 5-20.** River Stage Conditions at Transect 3 on 9/14/04 and 9/10/04 With 182 and 229 cfs Discharge at Lainhart Dam.

Stream Flow Measurement Site 9/14/04 12:05

Looking South at 35m North on Flowing Braided  
Channel 9/10/04 2:29

Edge of Floodplain 9/10/04 2:45

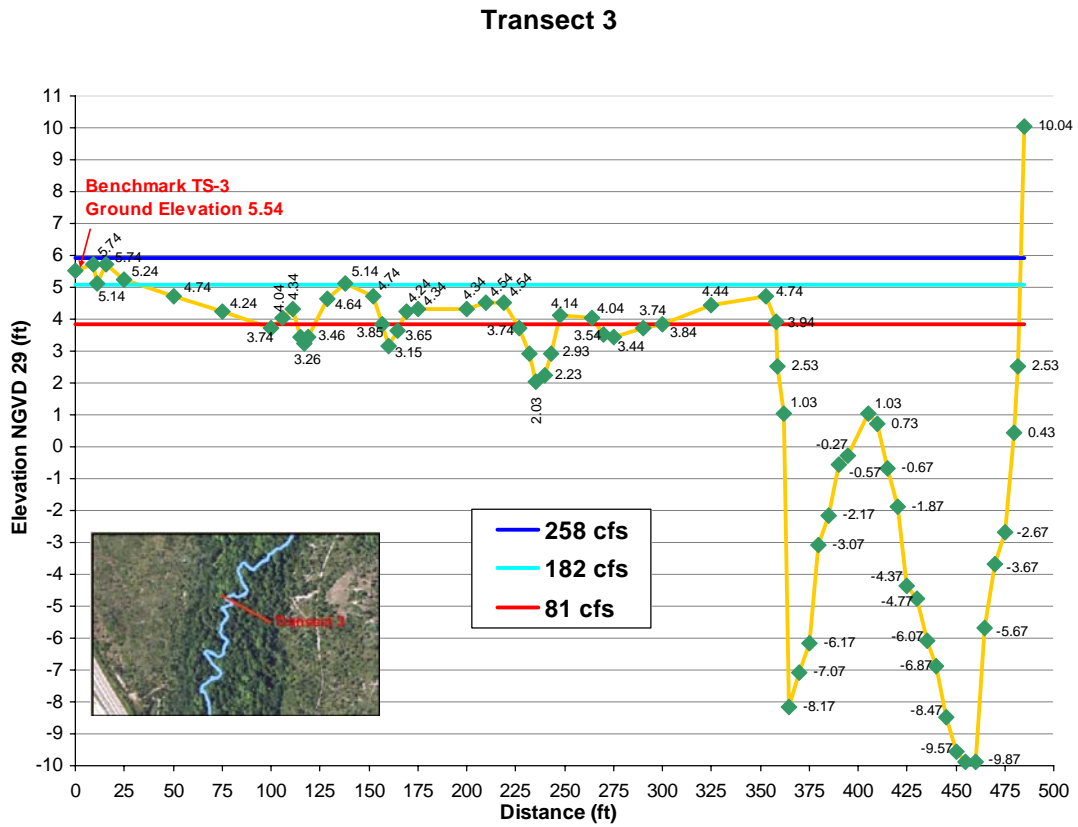
**Figure 5-21.** Transect 3 Cross Section and Observed Inundation Depth and Extent.

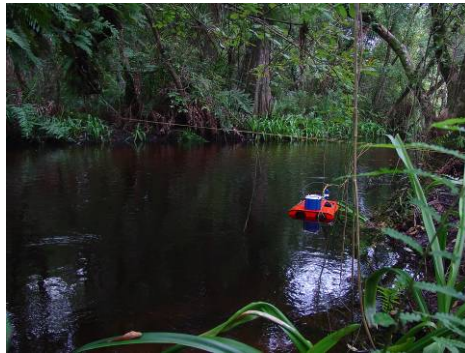
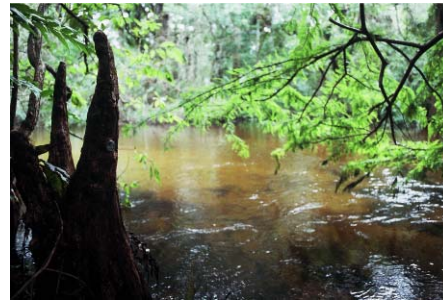
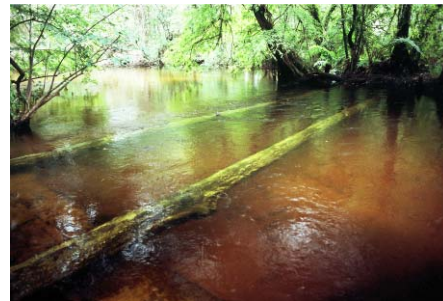
**Figure 5-22.** River Stage Conditions at Transect 4 on 8/13/04 and 8/17/04 with 83 and 93 cfs Discharge at Lainhart Dam.

- 83 cfs 8/17/04 3:30
- 93 cfs 8/13/04 12:49
  - No Flow Outside of Channel

Stream Flow Measurement Site 8/17/04 3:42

Stage Measurement Site Tag #608 8/13/04 12:56

Double Logs in Channel 8/13/04 1:00

**Figures 5-22 through 5-25** are photographs of the river and floodplain at Transect 4 taken over a range of flows from 83-461 cfs. **Figure 5-26** is a cross-sectional profile of the transect. It depicts the depth and lateral extent of floodplain inundation observed over the range of flows observed during the course of this floodplain evaluation.

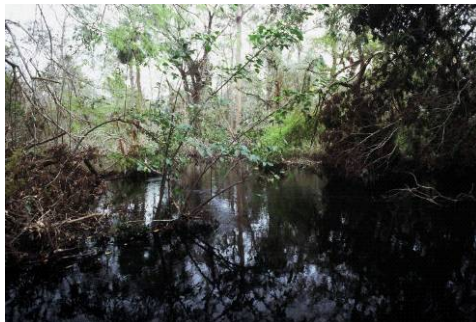
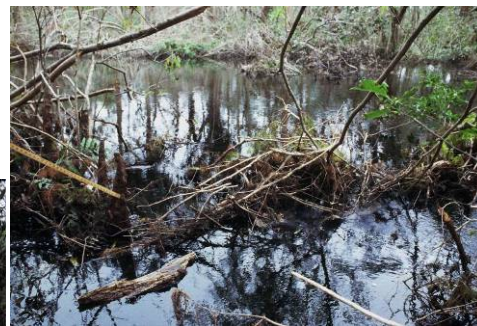
**Figure 5-23.** River Stage Conditions at Transect 4 on 9/14/04 With 186 cfs Discharge at Lainhart Dam.

- 186 cfs 9/14/04 1:25
  - No Visual Flow In Floodplain
  - Knee Deep
  - Dry Hummocks

Site of Double Logs in Channel 1:34

Stage Measurement Site Tag #608 1:26

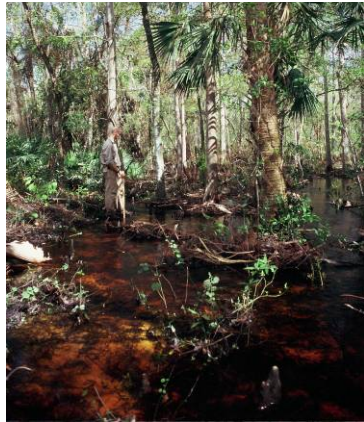
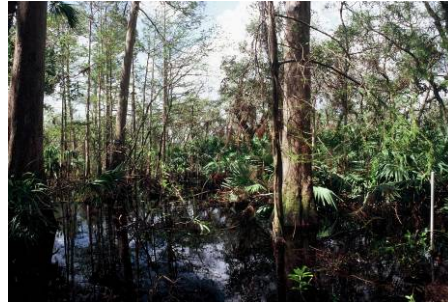
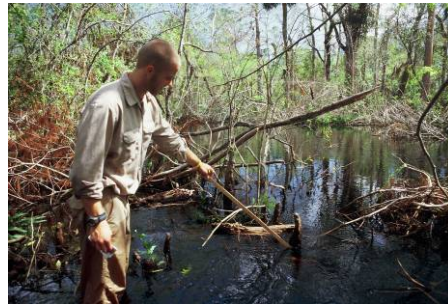
**Figure 5-24.** River Stage Conditions of Transect 4 at 9/23/04 With 309 cfs Discharge at Lainhart Dam.

- 309 cfs 9/23/04 11:36
  - Visual Flow Through Entire Floodplain
  - Waist Deep
  - Causeway Still Dry

Edge of Floodplain 11:05

At 25m South Looking Towards Floodplain 11:20

Stage Measurement Site Tag #608 11:40

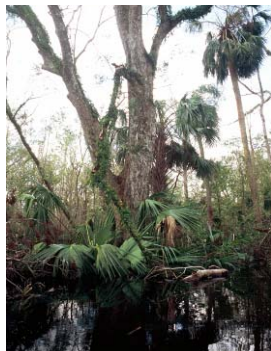
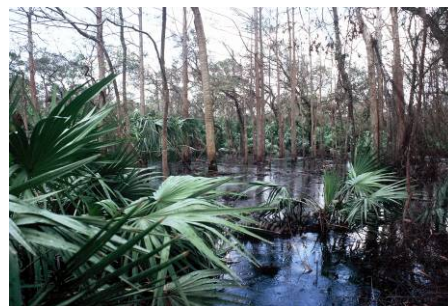
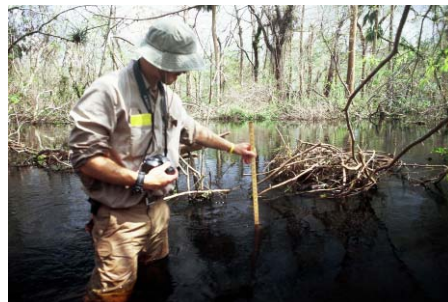
**Figure 5-25.** River Stage Conditions at Transect 4 on 9/29/04 With 461 cfs Discharge at Lainhart Dam.

- 461 cfs 9/29/04 12:30
  - Visual Flow Through Entire Floodplain
  - Over Waist Deep
  - Water Flowing Throughout the Floodplain
  - Water Hickory at 85m 20" Deep

Water Hickory 12:51

Edge of Floodplain Looking North 1:05

Stage Measurement Site Tag #608 12:32

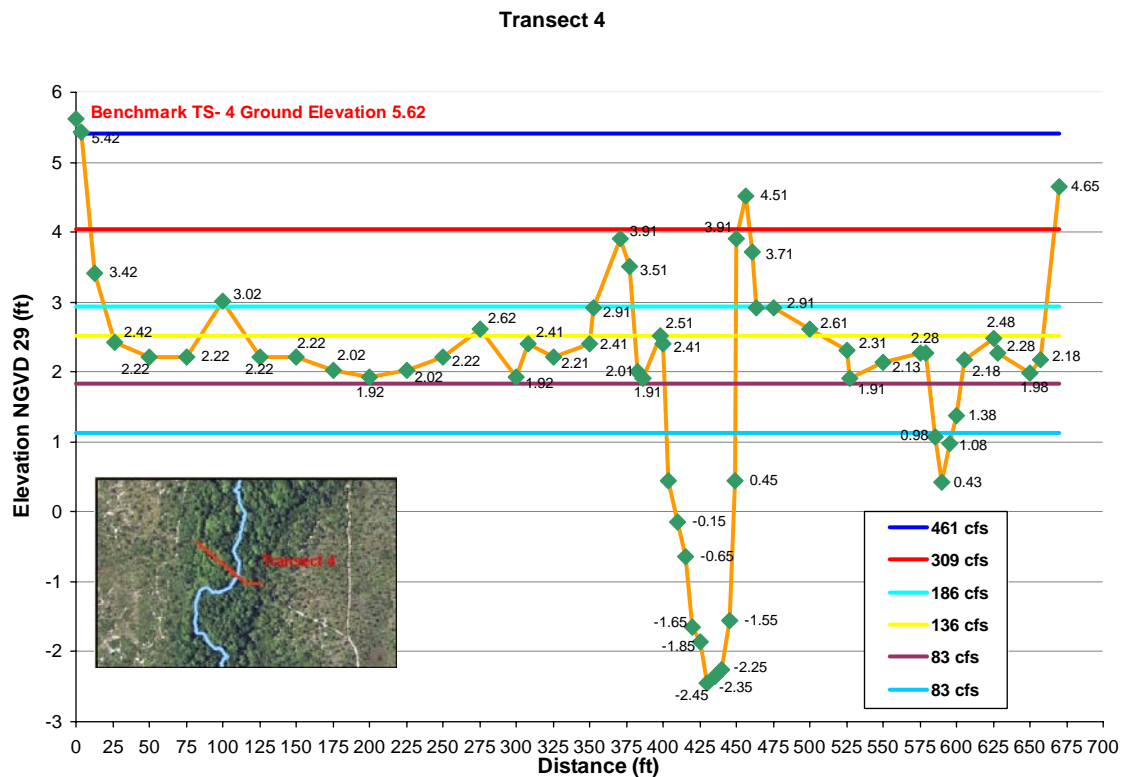
**Figure 5-26.** Transect 4 Cross Section and Observed Inundation Depth and Extent.

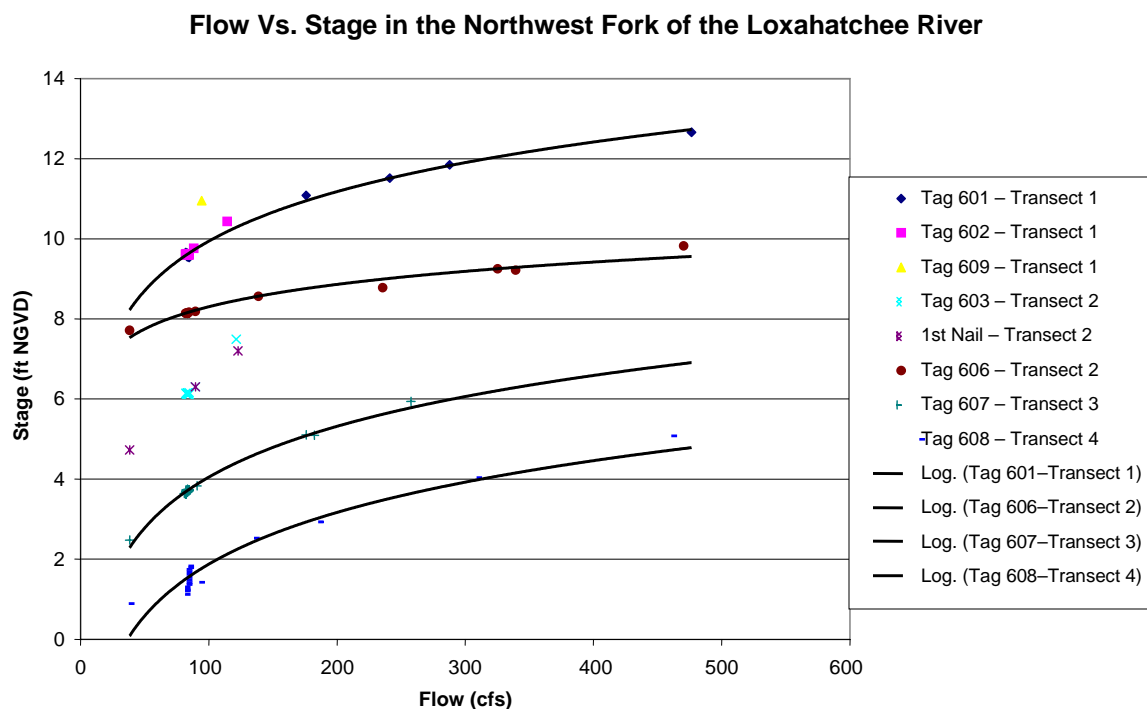
**Figure 5-27.** Observed Surface Water Stages at Various Discharge Rates Over Lainhart Dam. Tag Numbers Refer to Surveyed Benchmarks Placed Adjacent to the River Channel at the Study Transects.

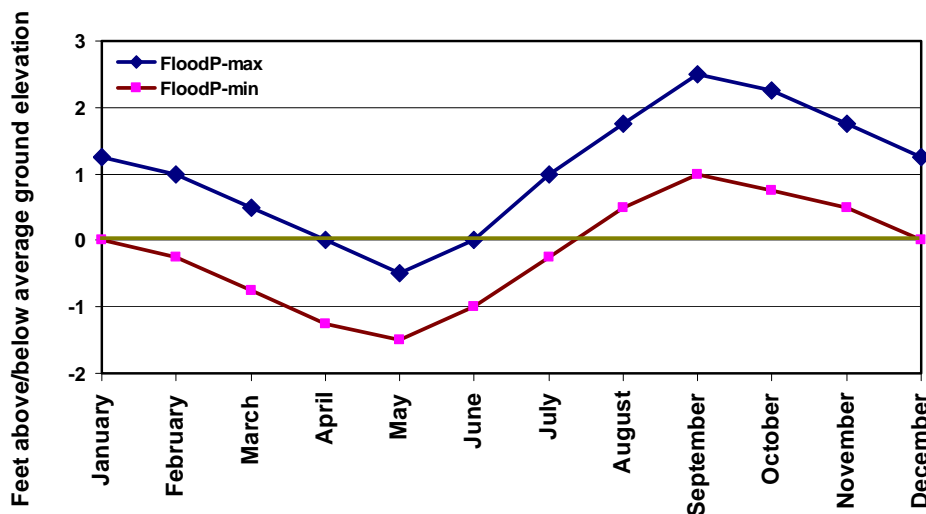
**Figure 5-28.** Annual Hydrological Performance Measures for Floodplain Swamps in the Northwest Fork of the Loxahatchee River.

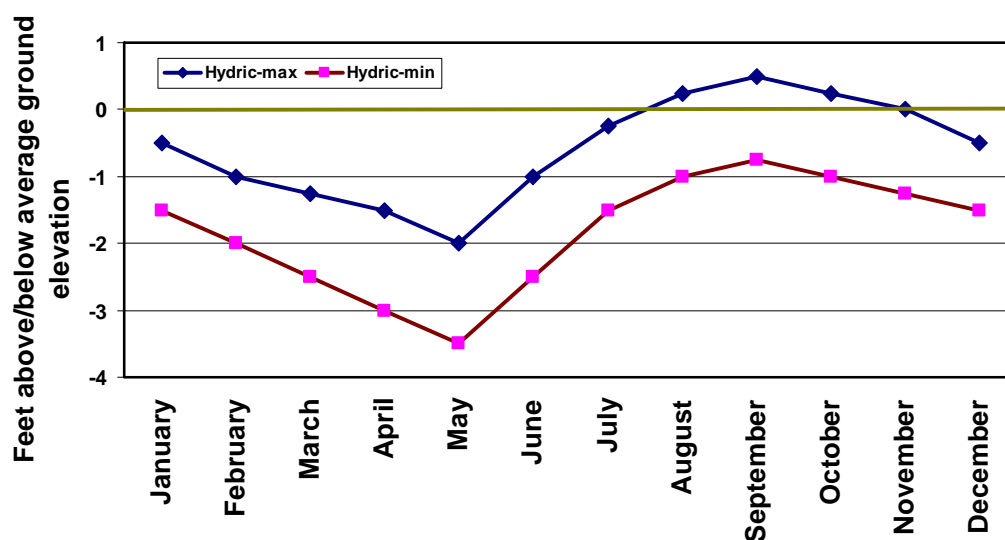
**Figure 5-29.** Annual Hydrological Performance Measures for Hydric Hammocks in the Northwest Fork of the Loxahatchee River.
